QUEENS MARKET BUILDINGS, RHYL

PRELIMINARY BAT ROOST ASSESSMENT, NESTING BIRD CHECK AND EMERGENCE SURVEYS

Report Ref EE.578.19.PK

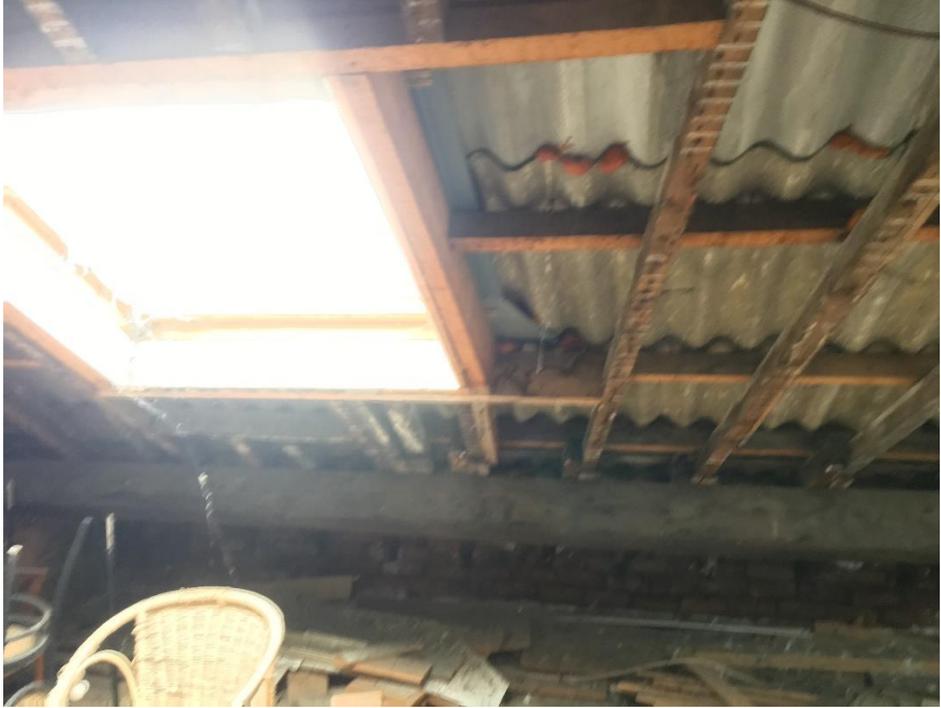
Building Feature	Description	Photos
Main Nightclub Building (NW of the site)		
<p>The roofs (where accessible)</p>	<p>The roof on this section of the site was made up of corrugated concrete/asbestos looking sheeting. No covering or render beneath with some light being seen between the sheets.</p> <p>The majority of the roof spaces which were accessible contained skylights on the north elevation, which illuminated the areas.</p> <p>There are a number of distinct roof loft spaces in the building and the majority of them are separated from each other with brick walls, however some of the walls are starting to fall down allowing spaces between lofts to form.</p> <p>The spaces appeared to be used occasionally for storage There was a good deal of cobweb cover.</p>

<p>Evidence of birds' nests were present in some of the wooden features, however no droppings or other evidence of bats using the roof spaces was observed.</p>	
Rooms within the building	<p>The rooms within the main building are unoccupied and used to be a hotel/ nightclub. Large north facing windows illuminate the northern rooms and the southern rooms are illuminated by un-shuttered smaller windows.</p> <p>There are in excess of 20 rooms within the main building. Many of these are associated with the old nightclub, however some were living accommodation. In several rooms around the building, there were windows left open and evidence of birds entering the building was observed.</p> <p>No evidence of bats was observed in any of the rooms within the main hotel building.</p>

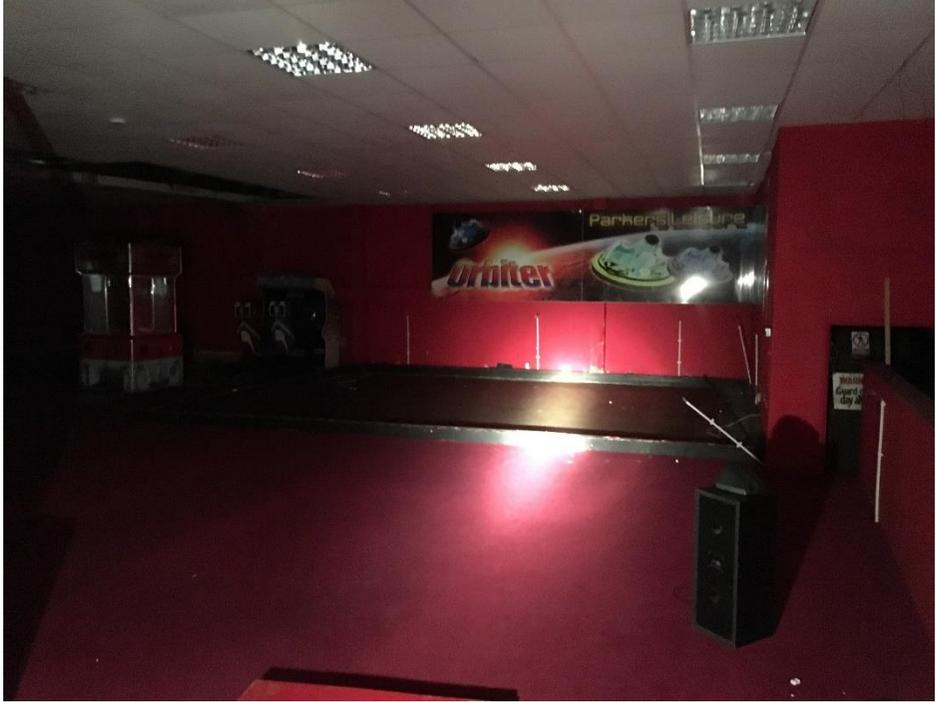
<p>Abandoned Arcade and storage rooms</p>	<p>On the ground floor of the main hotel building there is a large open space which was the old arcade. The only windows in the room are to the north which have been boarded to protect them from the street. As such the room is almost completely dark.</p> <p>To the south of the main open space there are several storage rooms which extend under the flat roofed section of the building to the back. These rooms were still full of the associated items for the arcade and the roof was leaking significantly.</p> <p>No evidence of bats was observed during the survey.</p>

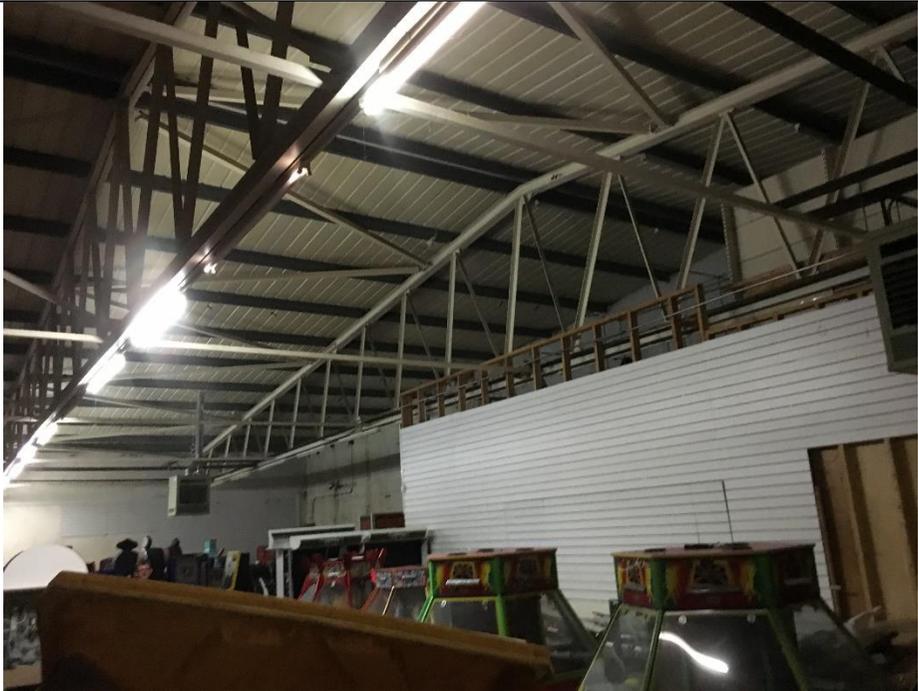
Queens Market Storage Rooms (NE of the site)		
Storage rooms	<p>In the north east of the site there is a large open building with a comparatively modern structure. The space inside is large and open with steel framework spanning the ridged metal roof. The area is currently being utilised as storage for unused arcade equipment.</p> <p>No gaps in the panelling were observed, potentially due to the height of the roof, however there was evidence of birds roosting within the space so there are likely to be some entrance and egress points.</p> <p>There is no natural light in the building and it is generally kept in darkness.</p> <p>No evidence of bats roosting was observed.</p>

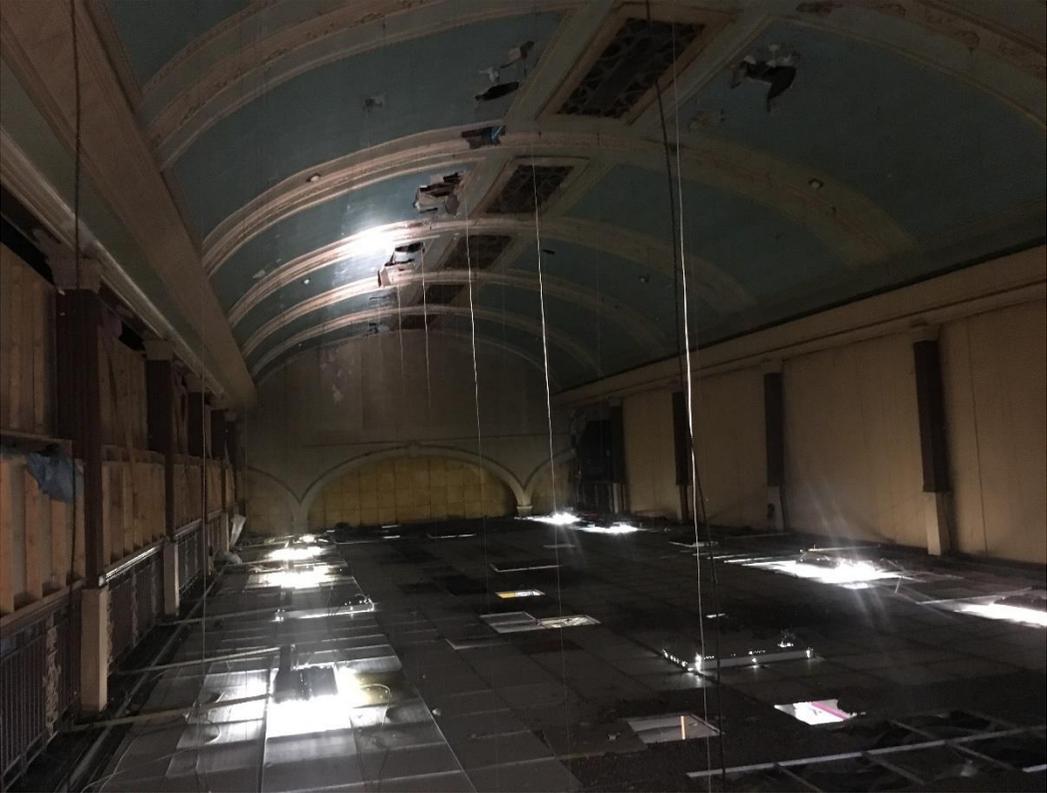
Queens Market		
Market Hall	<p>Within the main Queens Market, there was access above the suspended ceiling and so this is where the observations were taken from. Due to the lack of walkways and access, all observations were made from a platform.</p> <p>The concave ceiling had holes present in it where the supports for the suspended ceiling pass through the plaster to the joists above. There do not appear to be any holes allowing light from outside the building in to this space however, it is unclear what lies between the barrel shaped ceiling and the roof above. Light is present from the market below. N.B. The light on the ceiling in the photo opposite is from a torch used by a surveyor and not a permanent fixture.</p>

<p>It was impossible to closely inspect the walls and ceiling due to the size of the building and lack of access, however no evidence of bats was observed in the accessible areas.</p>	
Garages		
Garages	<p>Within the centre of the site there is a row of six single storey garages. The doors of three of these were damaged to the point where they were stuck open allowing sunlight to enter.</p> <p>Within the garages themselves, swifts (<i>Apus apus</i>) were observed entering and emerging during the daytime survey as well as a nesting pigeon (<i>Columba livia</i>).</p> <p>No evidence of bats was observed during the survey.</p>

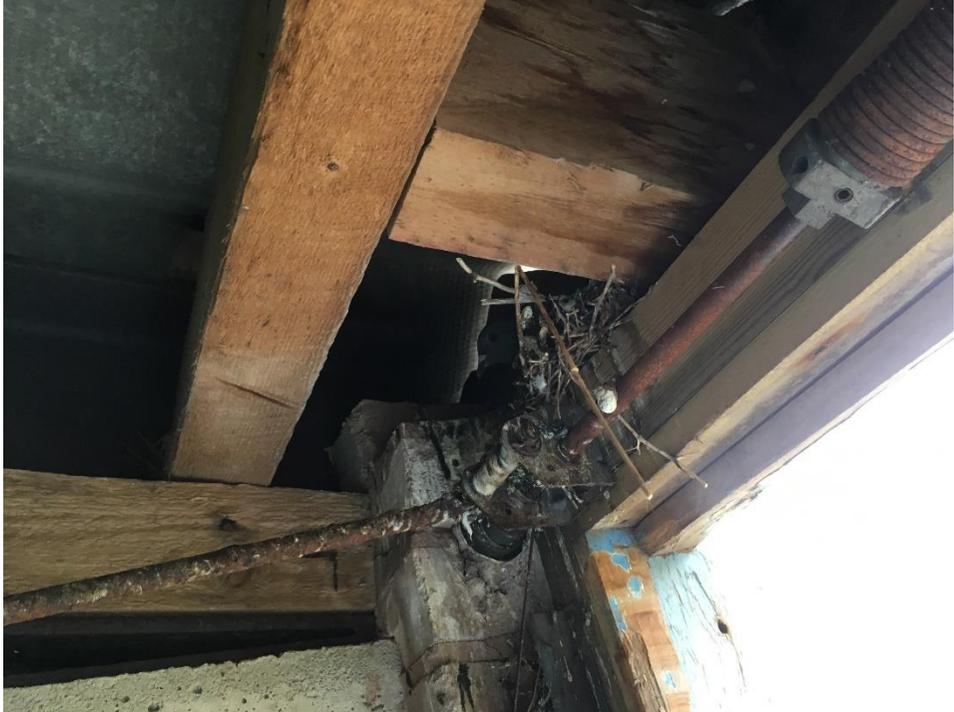
- 5.6 During the initial survey, swifts were observed nesting within the small row of garages in the centre of the site. In addition, evidence of birds nests were found within the main building, within the market place itself and also within the storage building in the north east of the

- 6.4 During the initial survey, swifts were observed nesting within the small garages in the centre of the site. These garages will be lost as part of the demolition and their loss should be mitigated onsite with provision of nine (three sets of three) inbuilt swift boxes incorporated within the final project, an example of this is the Manthrope swift brick. The exact location for these should be decided once a final design is fixed.

- 7.2 Within the site nine swift boxes should be erected in the final design to mitigate for the loss of the garages where swifts currently roost. These should be erected in line with guidance including:

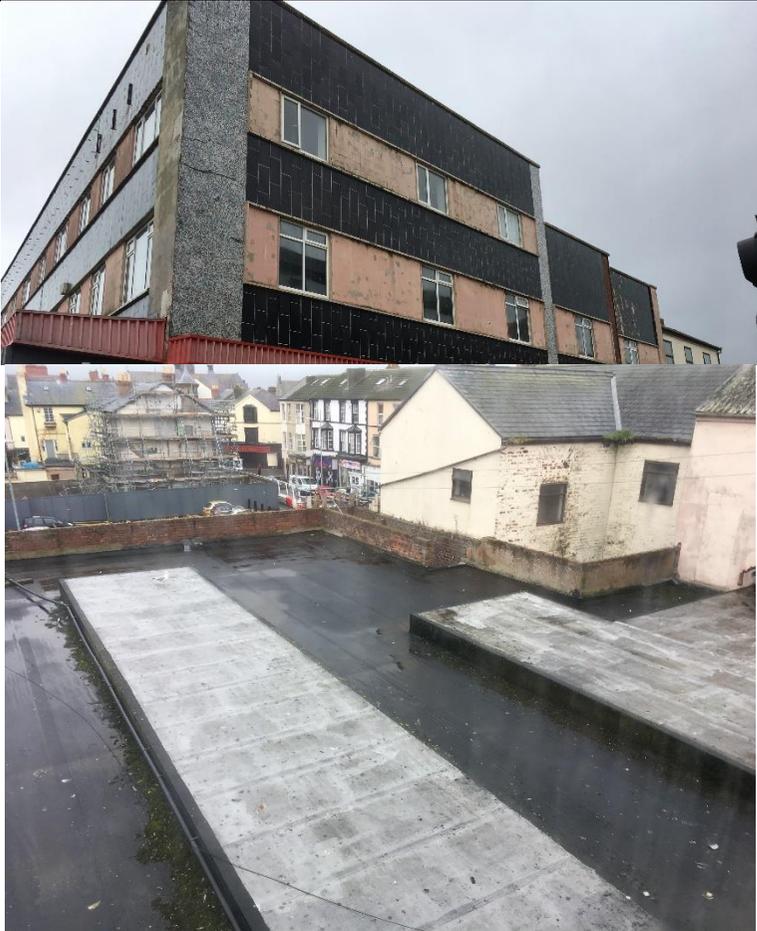
Building	Description	Photos
Main Nightclub	<p>In the north west of the site there is the main Nightclub building. This building is covered in a mixture of cladding and render which are both in a poor state of repair. The building is three stories high, not including the loft spaces. Windows are generally closed however some have been left open. The roof of this part of the building was pitched and made up of, what appeared to be, asbestos panels. (The first of the photos opposite shows the section of the building with a pitched roof, however the pitch is obscured by the walls which rise above the wall plates.)</p> <p>To the rear of the building was a two storey elevation with a flat roof.</p> <p>There are cracks in the render and gaps in the cladding which have potential to offer roosting opportunities to bats.</p>

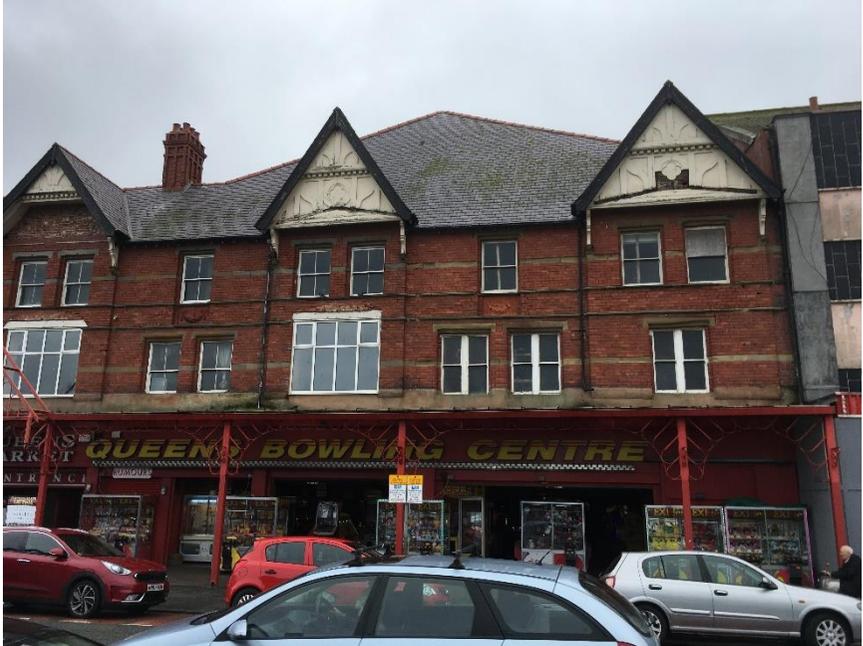
<p>Flats above Queens Bowling Centre</p>	<p>The roof for this building is slated with several additional dormer style pitches. The roof slates appeared to generally be in a good state of repair however, access was not permitted within this building so closer inspection was not possible due to health and safety issues. The wood work above the dormer style sections is rotten with several holes in the façade.</p> <p>No evidence of bats was observed, however there are several features which could allow bats entry in to this building including open windows and holes in the wooden facades.</p>

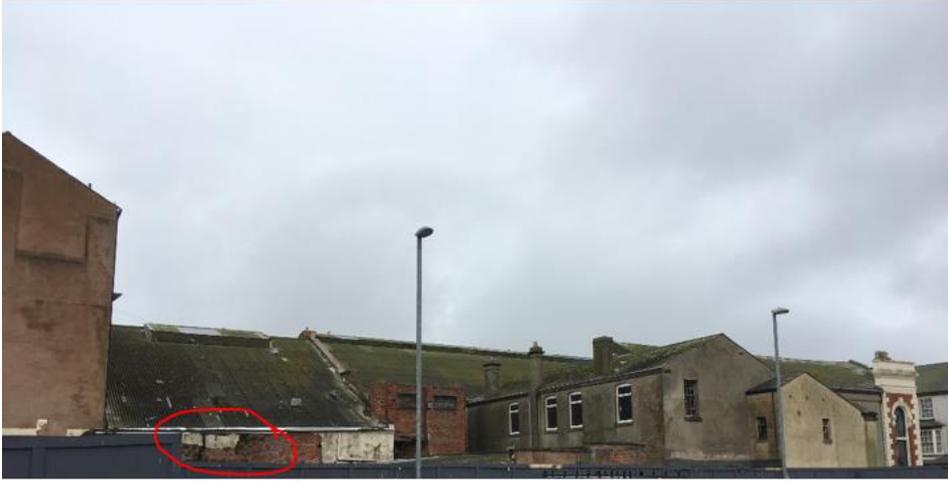
<p>Queens Market</p>	<p>The only view point of the external parts of the main Queens Market were from the west. From this location it could be seen that the roof over the top of the market was made up of, what appeared to be, asbestos sheeting. The walls were brick with several holes in them. Attached to this main building was a row of garages (see below) as well as a row of what appeared to be flats. No access was possible inside the flats.</p>

<p>Holes in the walls were visible (circled in red) in the main market building which would allow access for birds as well as bats in to the roof space.</p>	
Garages	<p>In the centre of the site to the west, there is a row of six single storey, block built, flat roofed garages. The doors to three of these are broken to the point where the doors cannot close and sunlight is allowed in. The other doors also have gaps around the entrance which would allow bats a point of entrance and egress. There was evidence of birds nesting within these buildings.</p>
